Maple Lake Shoreline Assessment Summary Report

Submitted by Watersheds Canada and the Canadian Wildlife Federation.

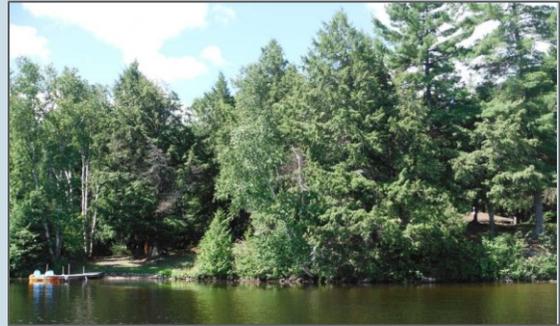
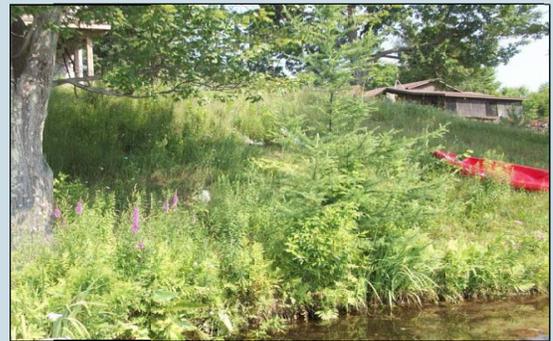
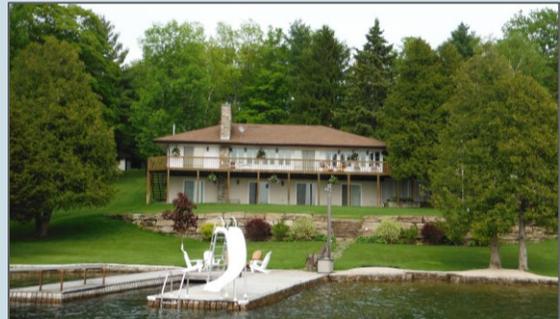
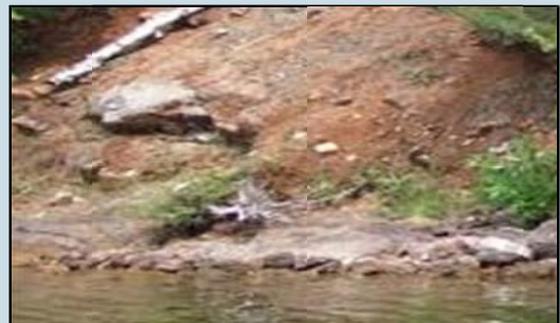
Photograph Example*

Natural – A healthy buffer of vegetation and/or a natural shoreline of sand or exposed rock that is undisturbed and undeveloped.

Regenerative – Natural vegetation has been removed in the past, but is in the process of growing back towards a natural state.

Ornamental – All natural vegetation has been removed and replaced with mowed lawn and other non-native vegetation; structures such as docks, decks, boathouses and boat ramps are predominantly present at the shore.

Degraded – Natural vegetation has been lost; soil erosion, undercutting of the bank and/or exposed roots of shrubs and trees are significant.

***Note:** These photographs are examples of shoreline classes, not representing any specific shoreline property on Maple Lake. There can be a range of variation in the classifications depending on the type of shoreline.
