Beech Lake Shoreline Assessment Summary Report

Submitted by Watersheds Canada and the Canadian Wildlife Federation.

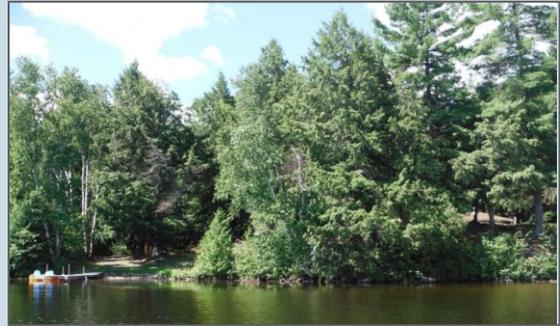
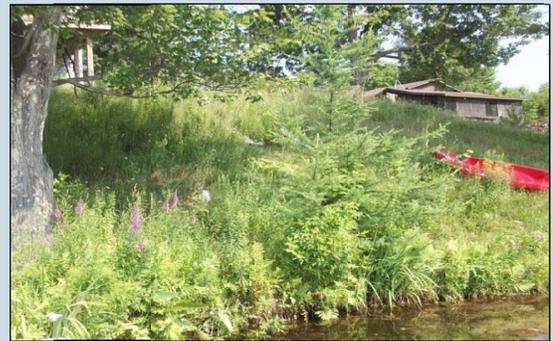
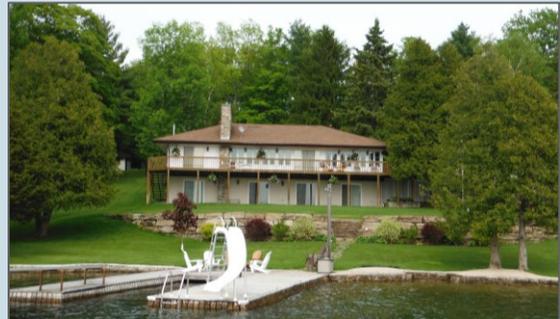
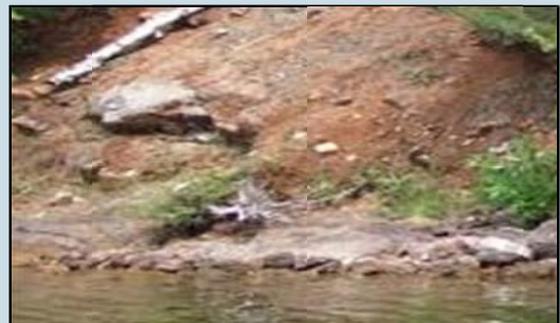
Photograph Example*

Natural – A healthy buffer of vegetation and/or a natural shoreline of sand or exposed rock that is undisturbed and undeveloped.

Regenerative – Natural vegetation has been removed in the past, but is in the process of growing back towards a natural state.

Ornamental – All natural vegetation has been removed and replaced with mowed lawn and other non-native vegetation; structures such as docks, decks, boathouses and boat ramps are predominantly present at the shore.

Degraded – Natural vegetation has been lost; soil erosion, undercutting of the bank and/or exposed roots of shrubs and trees are significant.

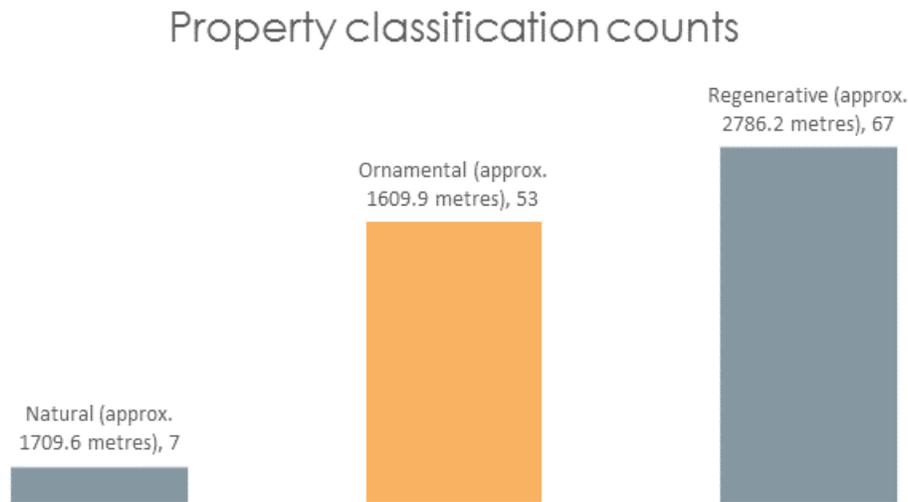
Figure 1 Property Classifications

Figure 1 shows the counts of property classifications on the lake. For example, a property that was 60% Natural, 20% Ornamental and 20% Regenerative would be classified as Natural. Alternatively, a property that was classified as 40% Ornamental, 30% Regenerative and 30% Natural would be classified as Ornamental.

On Beech Lake, 7 shoreline properties were classified as majority natural, 53 majority ornamental and 67 were considered majority regenerative. It is recommended that shoreline property owners engage in naturalization projects to further decrease the ornamental percentage and increase the regenerative and natural percentages.

This presents an opportunity for residents of Beech Lake to increase the overall quality of the lake by maintaining, protecting and enhancing natural shorelines. To restore shorelines to a more natural state, property owners are encouraged to take action. Regenerative properties should also be encouraged to maintain their properties in a natural state by allowing their vegetation on their property to continue to regenerate and grow naturally.
