Cameron Lake Shoreline Assessment Summary Report

Submitted by Watersheds Canada and the Canadian Wildlife Federation.

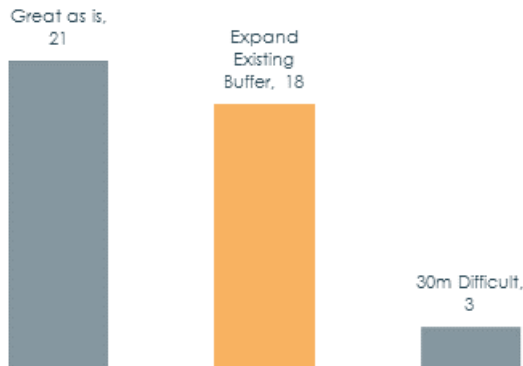
Figure 2 Buffer Recommendations

The survey of Cameron Lake characterized the types of restoration opportunities that exist around the lake on individual properties. Figure 2 summarizes the number of properties that were assigned a buffer recommendation during the survey. Each shoreline property can receive more than one recommendation.

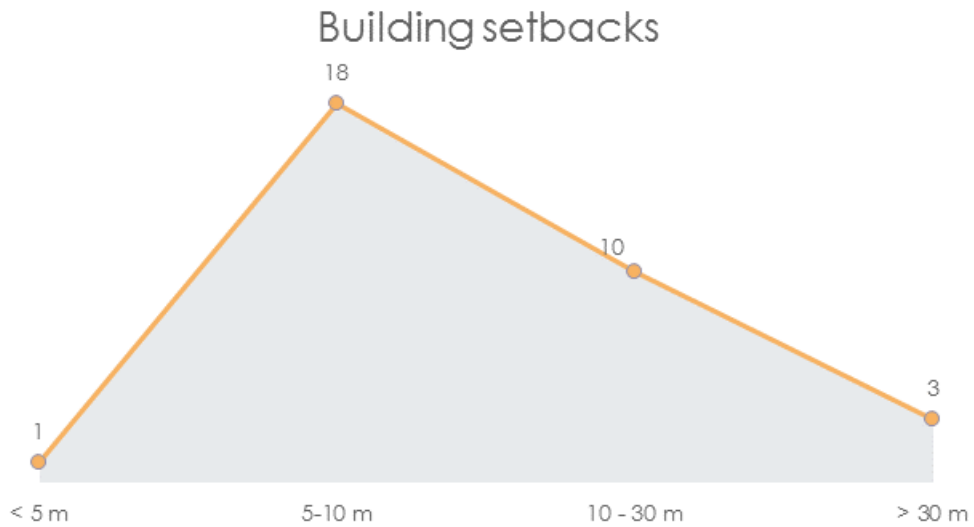
Figure 5 Building Setback Ranges

Shown in Figure 5 is the range of building setbacks for properties on the lake, not including vacant properties, buildings under construction and unidentifiable properties. Building setbacks for shoreline developments in Ontario should be at least 30 metres from the high water mark; however, older cottage buildings were

permitted closer to the high water mark. On Cameron Lake, 74% of the properties surveyed were observed to be closer than 30 metres to the shoreline.

A potential area of concern with building setbacks is having septic systems installed close to shore. Regular inspections and maintenance of septic systems can help prevent excess nutrients from entering the lake. Nutrients entering the lake can contribute to eutrophication, resulting in increased aquatic vegetation, low oxygen levels, turbid water and algal blooms. Excess nutrient loading is one of the largest threats to water quality in lakes and rivers; it is everyone’s responsibility to do something to help protect the lake.

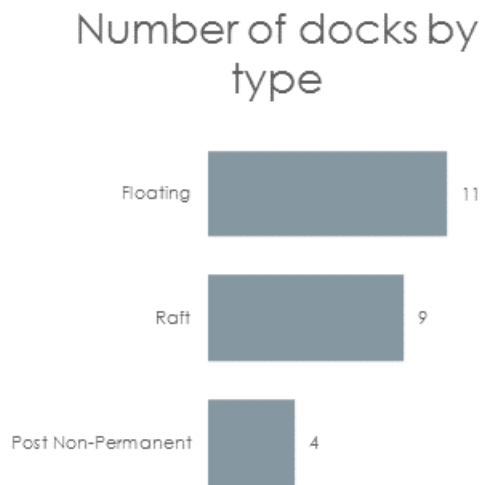
Figure 7 Docks On Lake

Shoreline development is defined as the presence of man-made structures in the water or along the shoreline within three metres of the shore. Development along a shoreline can be done sustainably and in an environmentally sensitive fashion, providing structures are well maintained and kept to a minimal footprint. Figure 7 and 8 illustrate the common structures present on Cameron Lake.

Small floating or non-permanent post docks are the most environmentally friendly choice, they allow natural water flow, have limited contact with the lake bottom, and reduce the overall potential for disturbance to aquatic life.

In the future, if shoreline property owners need to replace their old or failing permanent post, solid, or crib docks, they could consider choosing non-permanent post or floating docks. By selecting these types of docks,

people can reduce the potential impacts to fish and other aquatic species, which can help protect the overall health of the lake environment.

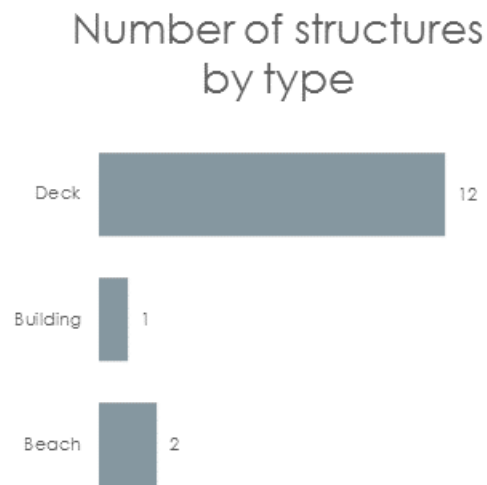
Figure 8 Structures on Lake

On average property owners have developed 14% of their shoreline within a few metres of the water's edge. Different types of structures can have negative environmental impacts, due to their ability to remove habitat, store contaminants and nutrients, and eventually release them into the aquatic environment.

When shoreline development structures are present, keep structures clean and organized to prevent possible soil and water contamination. Consider planting native species to provide additional habitat between man-made structures and the shoreline. If an older structure is present and no longer functioning, consider retiring the building, shed or other man-made structure, this will provide more habitat potential for wildlife.

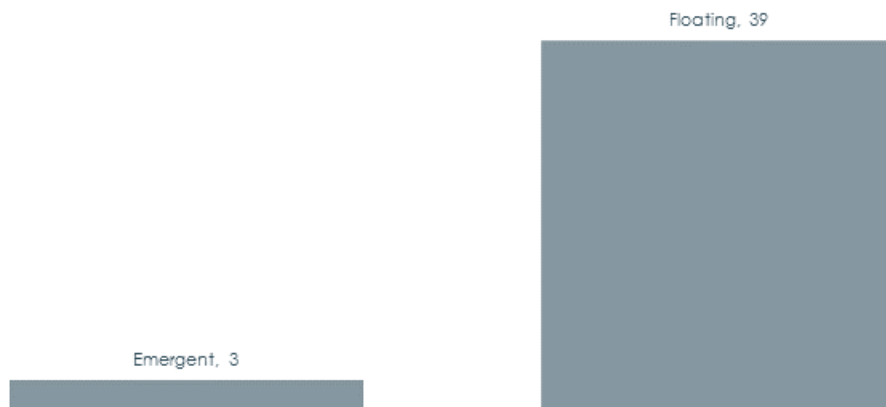
Figure 9 Aquatic Vegetation

On Cameron Lake, shorelines were surveyed for their presence of aquatic plants. The presence of aquatic plants was further summarized into aquatic vegetation types; emergent, submergent, floating and algal blooms. Figure 9 shows the number of properties on Cameron Lake that had aquatic plants along their shoreline properties. The majority of aquatic vegetation that was present on Cameron Lake was categorized as floating vegetation. Emergent vegetation was also found. Aquatic plants are still an important part of the aquatic ecosystem; giving habitat to birds, frogs, dragonflies and other wildlife.

When aquatic vegetation is removed, the integrity of the shoreline is lost. This negatively impacts the health of the waterbody by decreasing the quality of the water and reducing biodiversity. Eventually, a waterbody can become unusable, affecting the hundreds of species that rely on it. Fortunately, there are some easy steps that can be taken to help protect and restore your shoreline. By planting native species and allowing natural aquatic vegetation to grow, you can help provide habitat for wildlife to flourish.

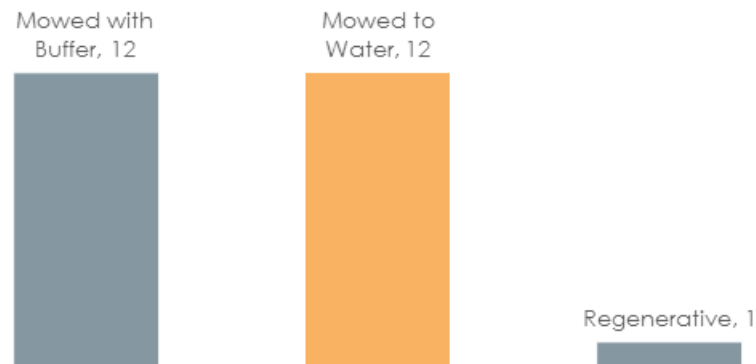
Figure 12 Lawn types

On Cameron Lake, the number of properties with lawns, either mowed or regenerative, was observed. 31% of properties had lawns that were mowed to the water's edge. When lawn is maintained to the water's edge, natural ground cover and native vegetation are no longer present to slow runoff and allow nutrient filtration. Nutrients, contaminants, pollutants and other harmful substances can be easily carried into the lake by runoff and can harm water quality and local ecological integrity. Lawn grasses also have short root systems and do not bind the soil well, which can lead to problems with erosion and increased sediment deposition.

In areas close to shore, a lawn is generally not a good choice of ground cover. Half of precipitation runs off a mowed lawn directly into the lake, instead of returning to a natural groundwater source. If shoreline property owners wish to mitigate this, they could consider allowing vegetation to regenerate on its own or by actively planting native trees, shrubs, grasses, or alternative ground cover. The roots of the vegetation will grip the soil which can help prevent erosion. Allowing mowed lawns to regenerate to a more natural state promotes water conservation and protects surface and groundwater resources. Properties with regenerative lawns are encouraged to allow this natural process to continue and to enhance regeneration by planting native trees and shrubs.
